Office of the Chief Investigator
Transport Safety

**Rail Safety Investigation
Report No 2011/11**

**Signal Passed at Danger
V/Line Passenger Train 8415
Flinders Street Station
30 November 2011**

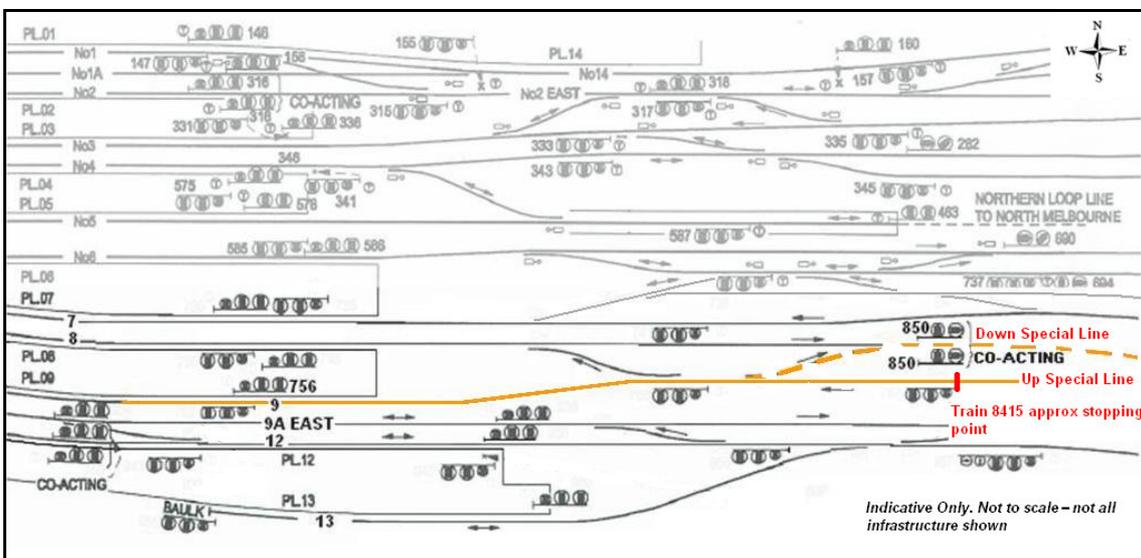
At 1249, after receiving the Conductor's radio message that 'station work was complete', the driver of train 8415 departed from Platform 9, passing Down² Home signal 756 while it was displaying a Stop indication. The driver reported that when he realised the train was travelling on the Up Special instead of the Down Special line he immediately brought it to a stand—about 380 metres beyond signal 756.

Figure 1: Solid orange line indicates path taken by train 8415 from Platform 9 onto the Up Special line. Dotted line indicates intended route to the Down Special line

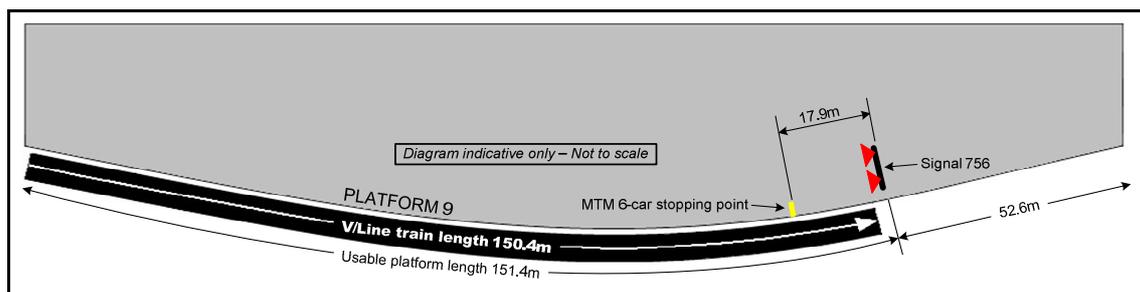
Platform 9 at Flinders Street Station is 204 metres long on a slight convex curve and is signalled for bi-directional running. The distance between Home signal 756 and the stopping mark for a six-car suburban train is 17.9 metres. An array of platform monitors, providing Down suburban train drivers with views towards the rear of their train, is located ahead of this stopping mark.

Figure 2: Diagram showing dimensions relevant to the incident

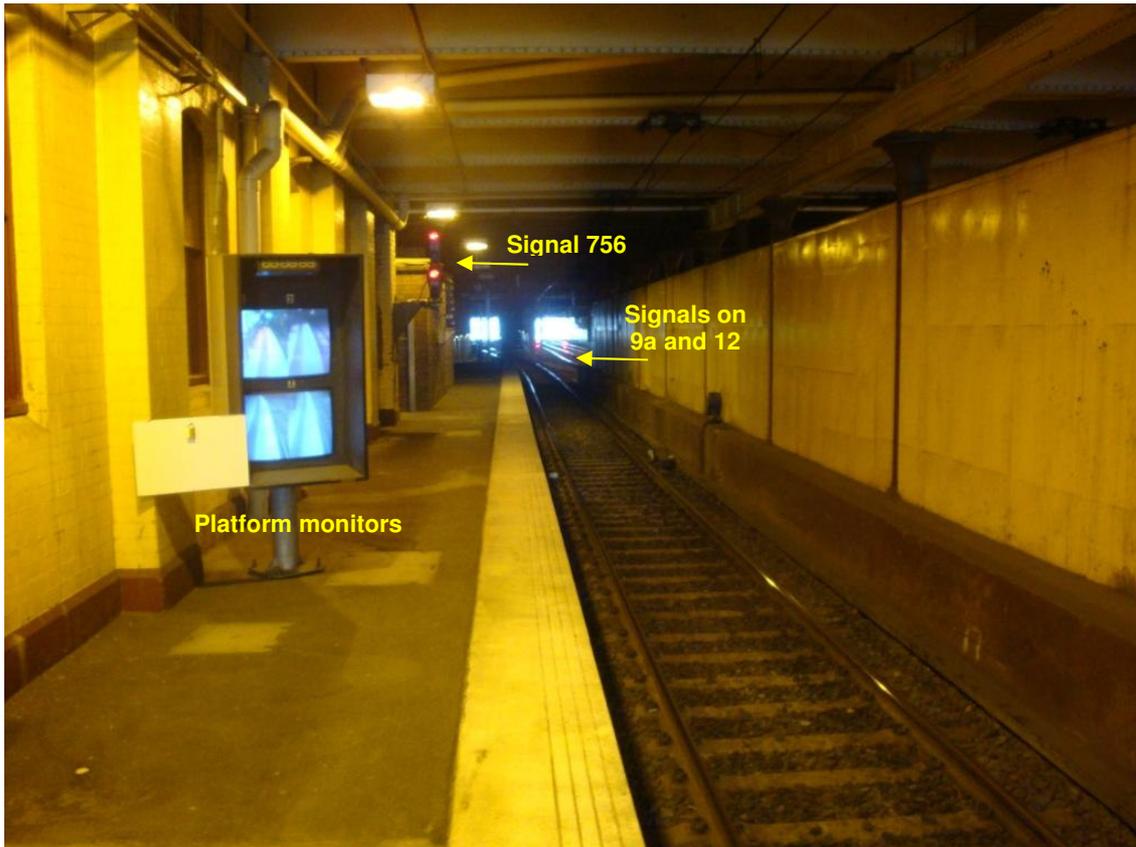
Figure 3: East end of Platform 9 showing platform monitors, signal 756 and other signals in the distance on tracks 9a and 12

The east end of Platform 9 is covered by Swanston Street and Federation Square, requiring the use of security lighting in the general area of signal 756 and towards the east end of the platform. This lighting has a detrimental spill-over effect on the visibility of signal 756.

Tracks 9a and 12 are adjacent to track 9. There is a solid bridge support beneath Swanston Street⁶ between Platform 9 and track 9a East that extends eastward to a point opposite the east end of Platform 9. When looking eastward along Platform 9 the signals applicable to eastward (Down) movements along tracks 9a East and 12—which are fitted with LED heads—are clearly visible to a driver when stationary at signal 756 on track 9.

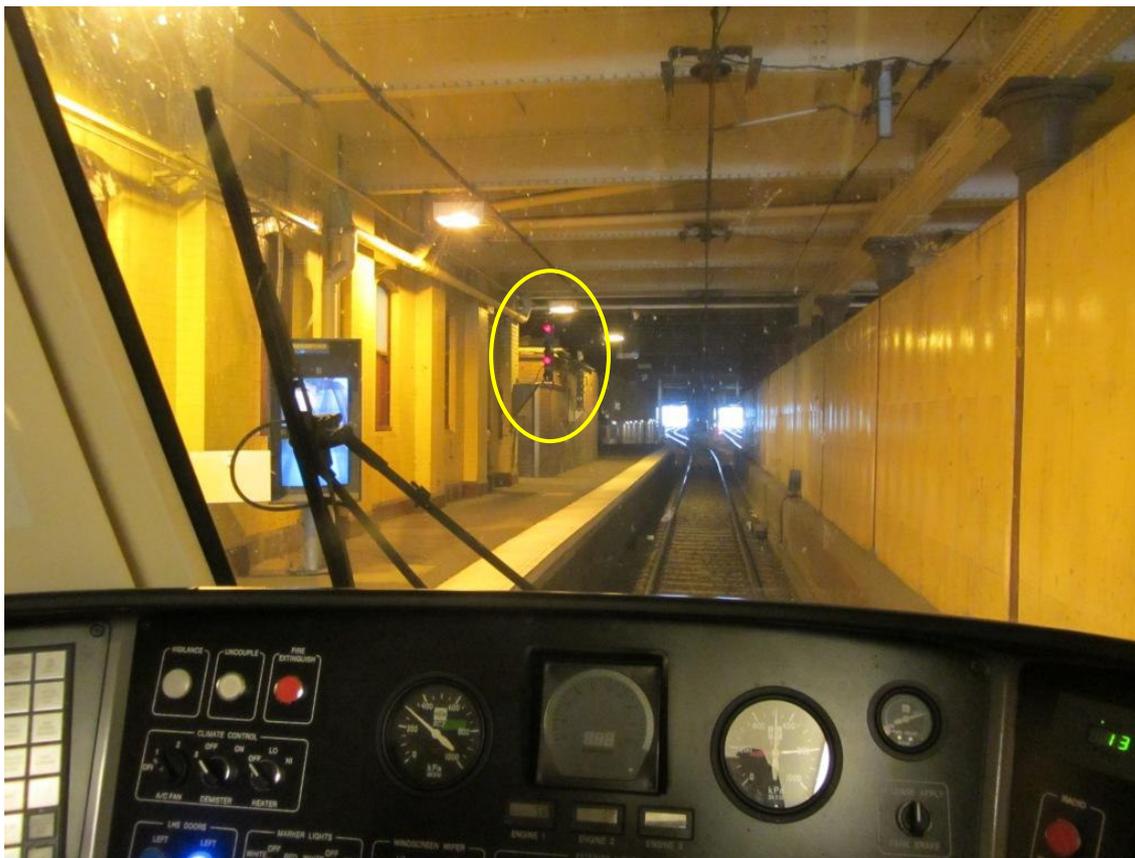
On Thursday 15 December 2011, sighting tests of signal 756 were conducted utilising a six car VLocity train. Observations were recorded from the driving position while moving along Platform 9 and at various stopping points near signal 756. With the driver's cab positioned at the six-car suburban train stopping mark the view of the signal 756 display was good, however the rear passenger door of the train was not on the platform.

Figure 4: View of signal 756 from the VLocity driver's cab at the six-car suburban stopping mark

Signal 756 was focused to favour viewing by the drivers of six-car suburban commuter trains stopping at the pre-determined location on Platform 9. When a six-car VLocity train is required to stop at the platform and signal 756 is at Stop, there is barely enough available platform length. As a result, the V/Line train was required to approach close to signal 756 to ensure the whole train was against the platform.

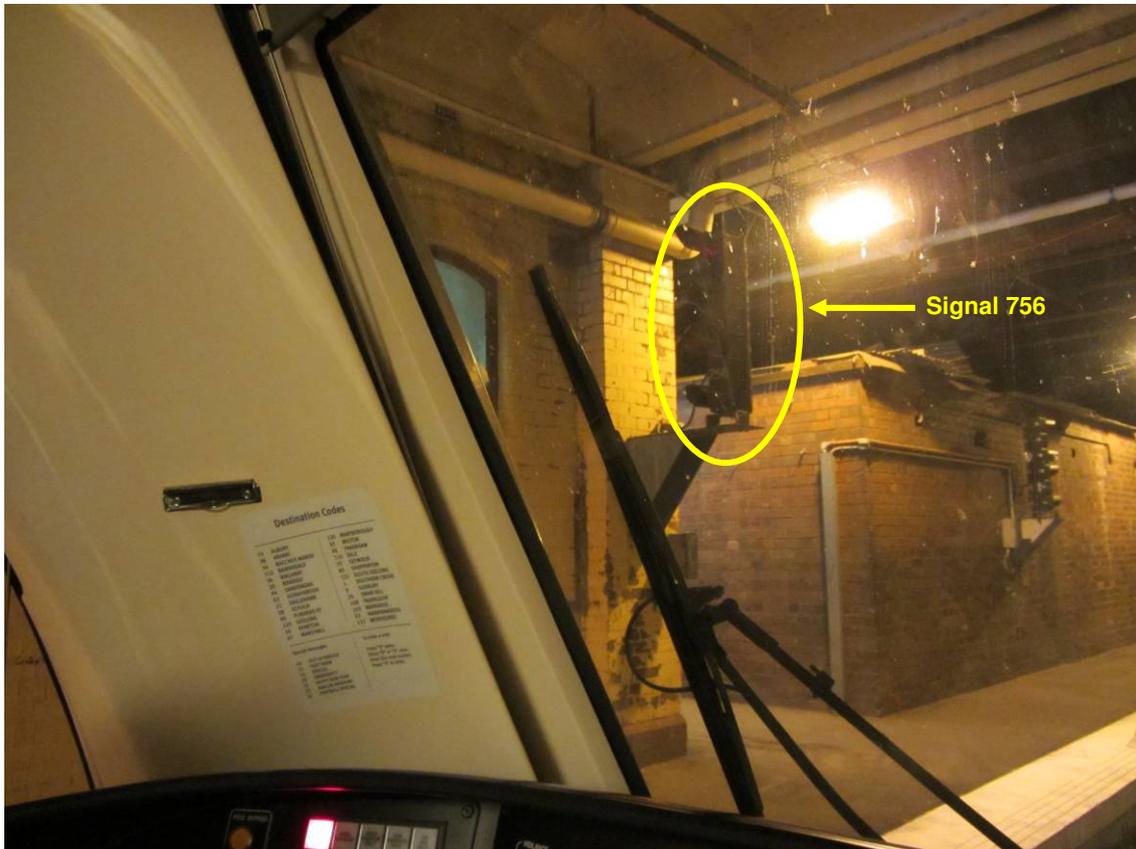
With the driver's cab of a VLocity train positioned forward of the platform monitors—as was the case with train 8415 on 30 November 2011—the sighting of any signal aspect from the driving position was severely restricted (Figure 5). The Signal Sighting Working Committee representatives conducting this review identified that the sighting of signal 756 would be significantly improved by conversion from incandescent lamps to wide spread (medium range) light-emitting diode (LED) lamps.

Figure 5: Driver's line-of-sight view from a VLocity cab to signal 756 at the approximate stopping location of train 8415

Signal 756 was equipped with standard incandescent lamps with standard lens hoods that provided a degree of protection for the display against the effect of the background security lighting. However, the close proximity of train 8415 to the signal meant that the driver's view of the signal display was compromised due to the limited viewing angle of the incandescent lamps, the sighting focus of the signal heads, the type of signal hoods fitted and the detrimental spill-over effect from security lighting. The sighting of this signal may have been improved by fitment of medium range LED lamps.

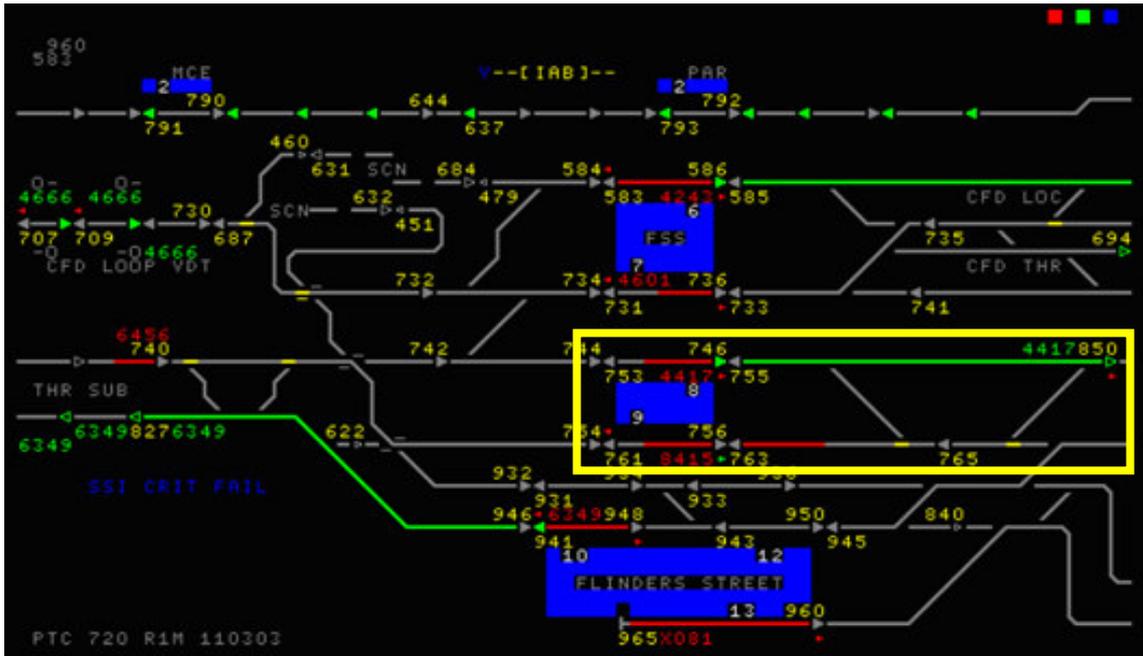
The Metrol Signal Logging system 'Log and Playback' confirmed that train 8415 at Platform 9 Flinders Street passed signal 756 at Stop and that the track section beyond this signal was occupied at 1248:52. At this time the route was set with the Home signal cleared for a Down suburban train to depart Platform 8. The signals for tracks 9A and 12 were at Stop and signal 850, about 350 metres ahead on the Down special line, was at Proceed (Green-over-Red).

Figure 6: Signal logging system snapshot at time of incident. V/Line train 8415 at Platform 9 has passed signal 756 and is heading towards the Up Special line. MTM train 4417 is at Platform 8 and is cleared to proceed on the Down Special line
